PLSLSC Back Beach Base Site Analysis + Concept Design Studies

Site Analysis + Concept Design Studies
20.10.2023
Revision 01

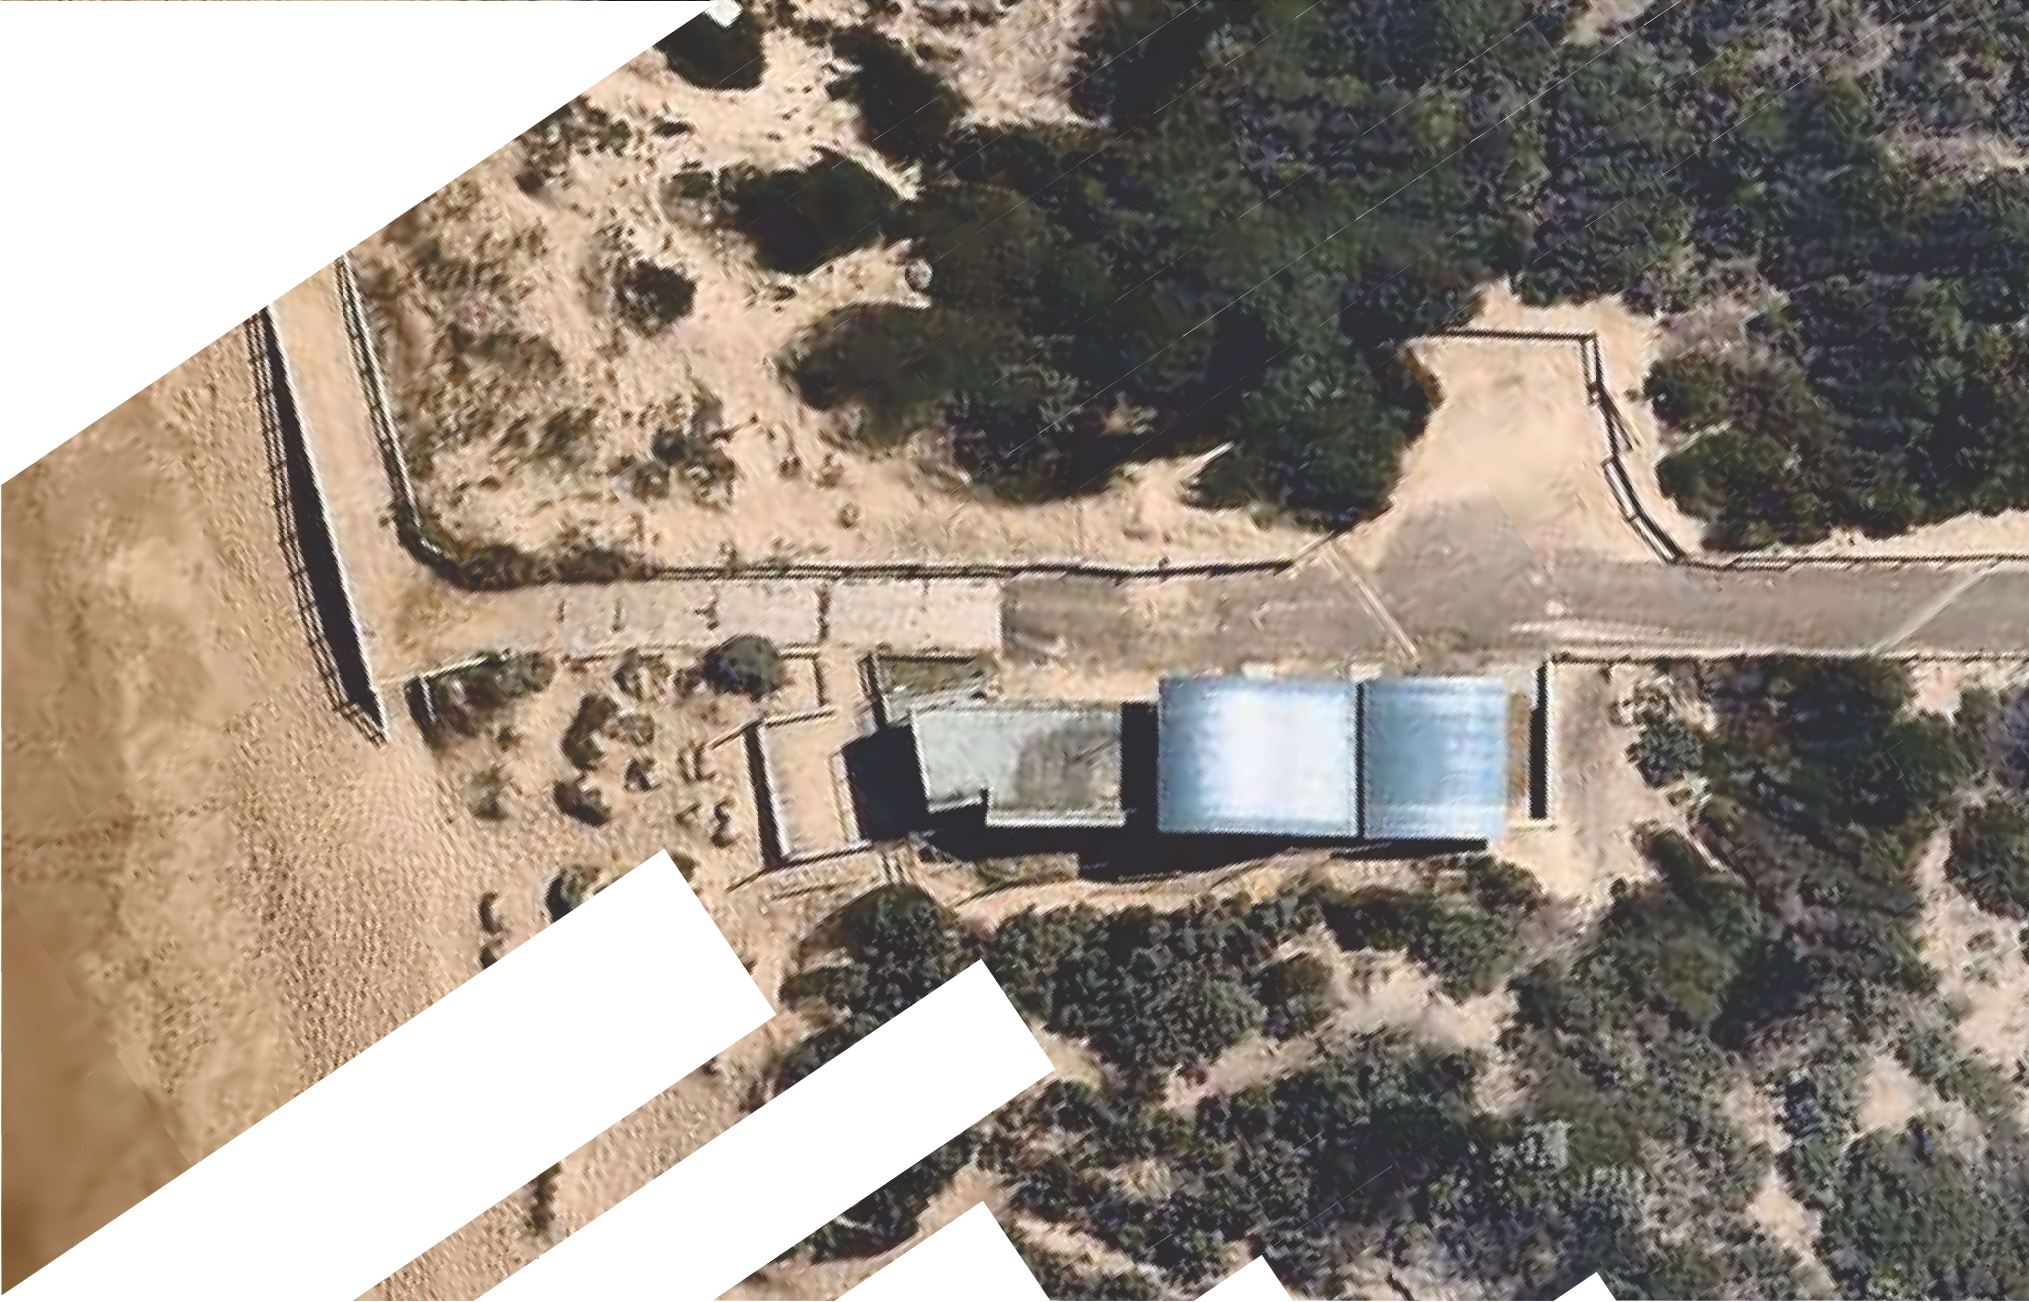
Existing BBB Facility

The existing PLSLSC Back Beach Base provides a critical life-saving service and patrol base to the back beach of Point Lonsdale.

The existing building is in urgent need of upgrade or replacement as it is no longer fit for purpose due to significant structural deficiencies and safety concerns.

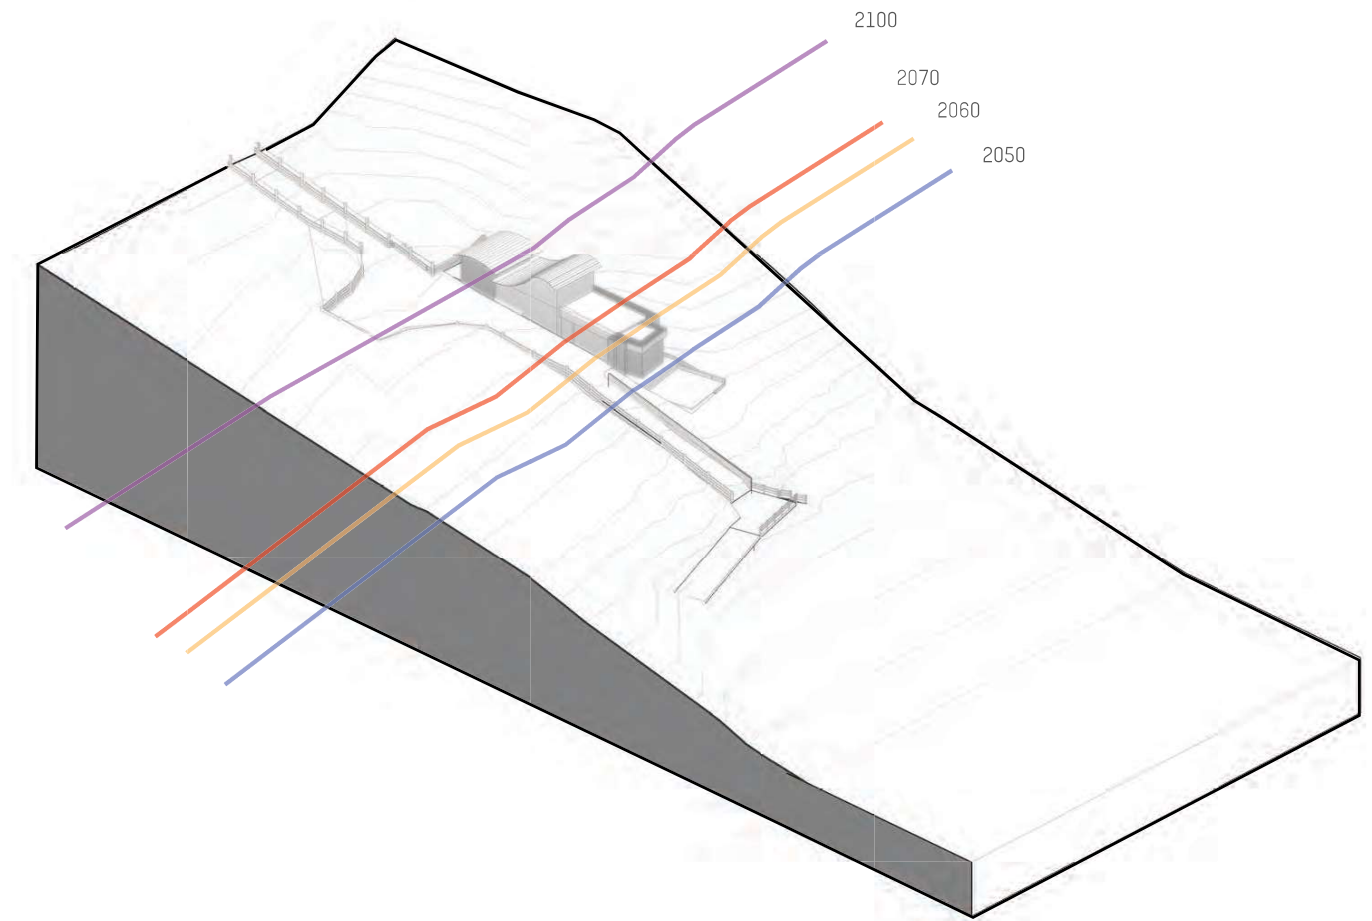
Sea Level Rise & Erosion Buffer

The future impacts of sea level rises provided by a Coastal Hazard Vulnerability Assessment (CHVA) have informed four Sea Level Rise (SLR) parameters and the resulting erosion buffers in relation to the existing footprint.

- SLR Buffer 2050
- SLR Buffer 2060
- SLR Buffer 2070
- SLR Buffer 2100

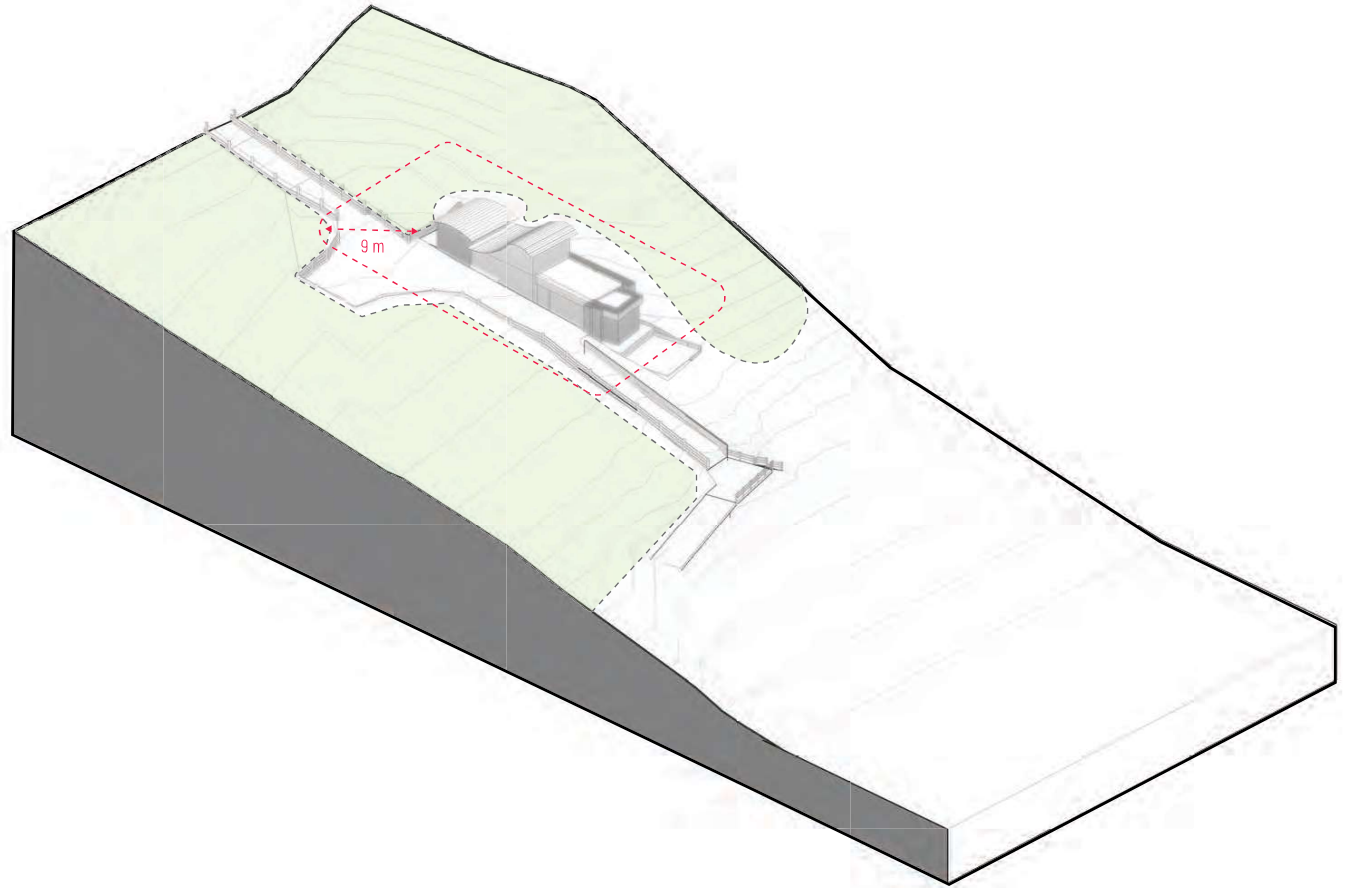
Ecological & Native Vegetation

The Coastal dune scrub and grassland within proximity of the existing building footprint will be subject to Defendable Space Management Plans.

Required defendable space
-

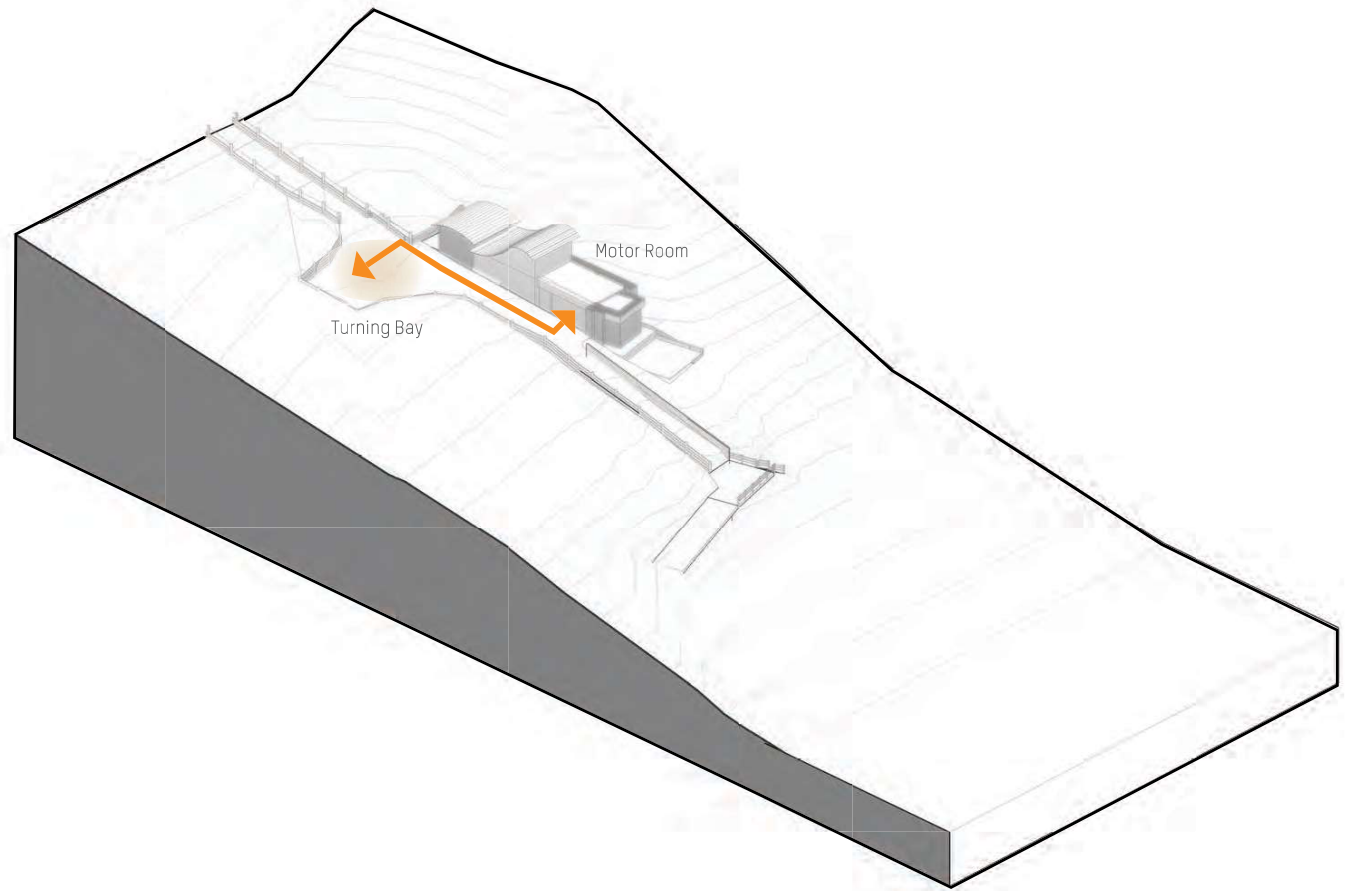
Vehicle Movement

The existing Motor Room is poorly located in relation to the existing vehicle turning bay. This causes difficulties manoeuvring club vehicles, given the distance and steep road gradient between the two, as well as safety issues for pedestrians when arriving or leaving the beach via the narrow thoroughfare.

Ideally the future BBB facility would locate the Motor Room in closer proximity to, or opposite to the turning bay.
